THIRD ENDORSEMENT on NAF, China Lake, AAR #3-58, concerning
F4D-1, BuNo 134762, pilot (b) (6)

SECOND ENDORSEMENT on NAP, China Lake AAR 3-58, concerning F4D-1 BuNo
134762, Pilot LCDR (b) (6) USN

FIRST ENDORSEMENT on NAF- China Lake AAR 3-58, concerning F4D-1 BuNo 134762,
Pilot LCDR (b) (6) USN

AIRCRAFT ACCIDENT REPORT

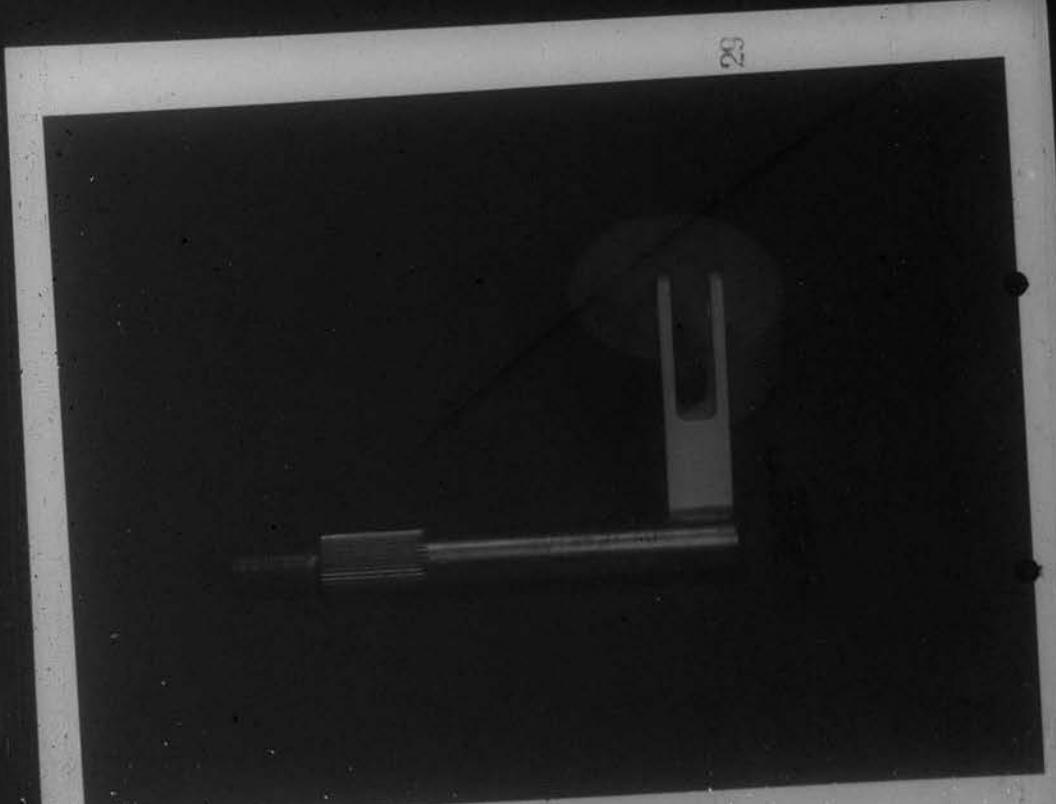
ES 172795 DOUGLAS
FDD-1 1210 5/19/58
ELEVON ACTUATING CRANK ASSY. (SUNO 134762)

The primary cause of this accident was material failure of the starboard elevon latch actuating crank pin, ultimately resulting in elevon seizure.
